# Ancient history, modern destruction:

Assessing the current status of Syria's World Heritage sites  
using high-resolution satellite imagery

September 2014

# Ancient History, Modern Destruction: Assessing the Current Status of Syria's World Heritage Sites Using High-Resolution Satellite Imagery

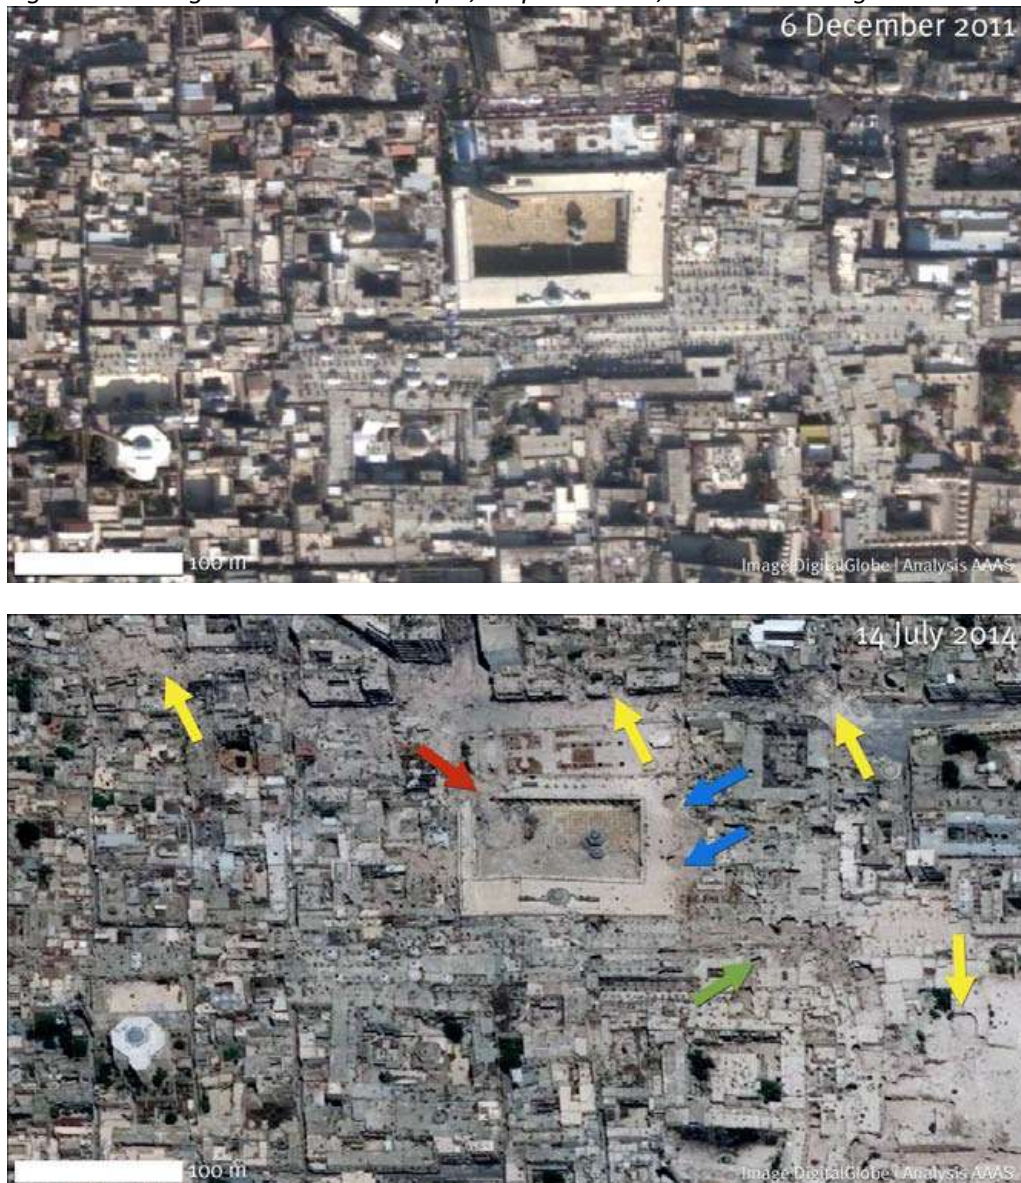
*Figure 3: Damage to the Great Mosque, Suq al-Madina, and surrounding area*

In spring 2013, it was reported that the minaret of the Great Mosque of Aleppo had been destroyed during the fighting. AAAS documented this damage in its August 2013 report. Since that time, two additional craters have appeared along the eastern wall of the mosque. The nearby Suq al-Madina was also heavily damaged, as were multiple other structures (Figure 3).

*Between 6 December 2011 (top) and 14 July 2014, the roof of the Suq al-Madina was damaged (green arrow), the minaret of the Great Mosque was destroyed (red arrow) and two craters appear on the eastern wall (blue arrows). In addition, multiple nearby structures were heavily damaged (yellow arrows). Images ©2014, DigitalGlobe, NextView License | Analysis AAAS. Coordinates: 36.19N, 37.15E.*

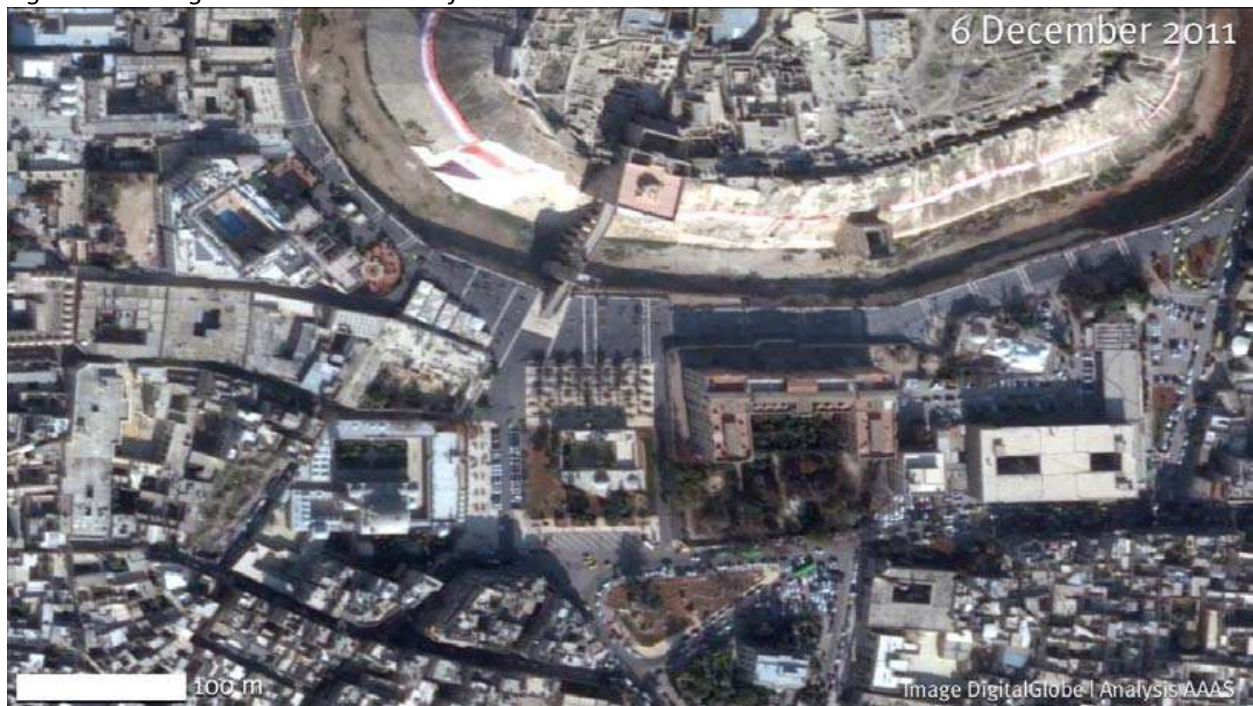
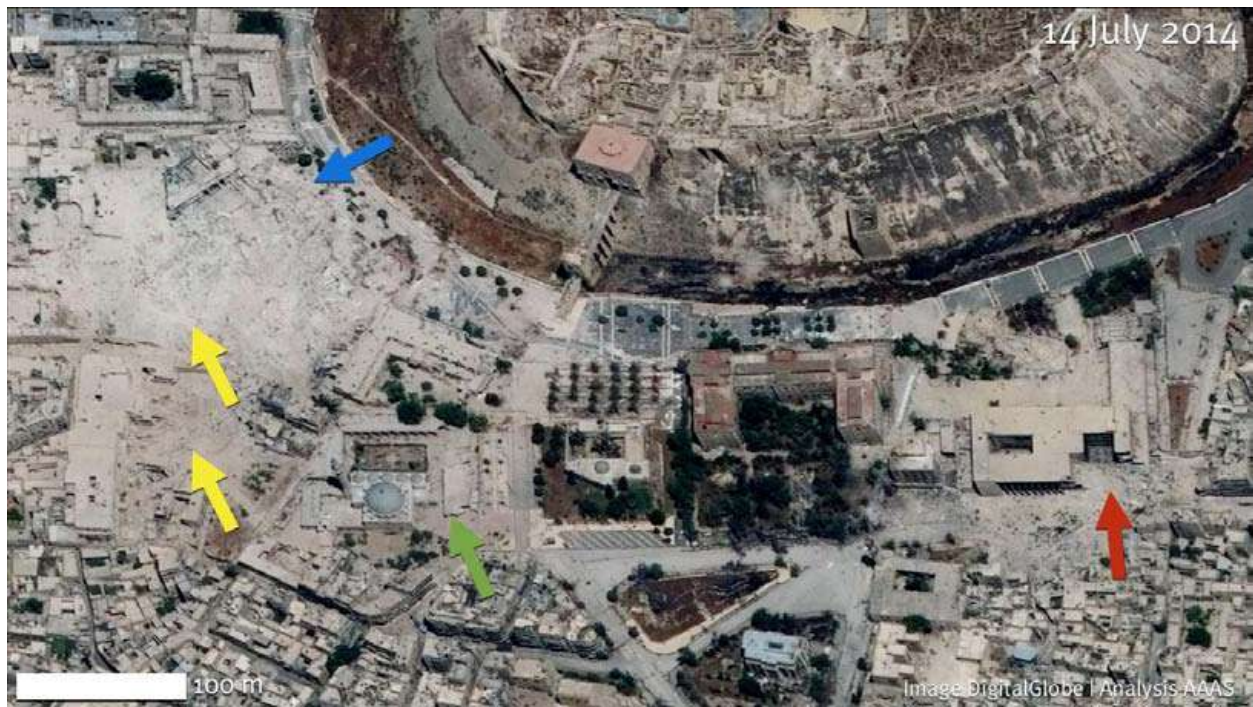
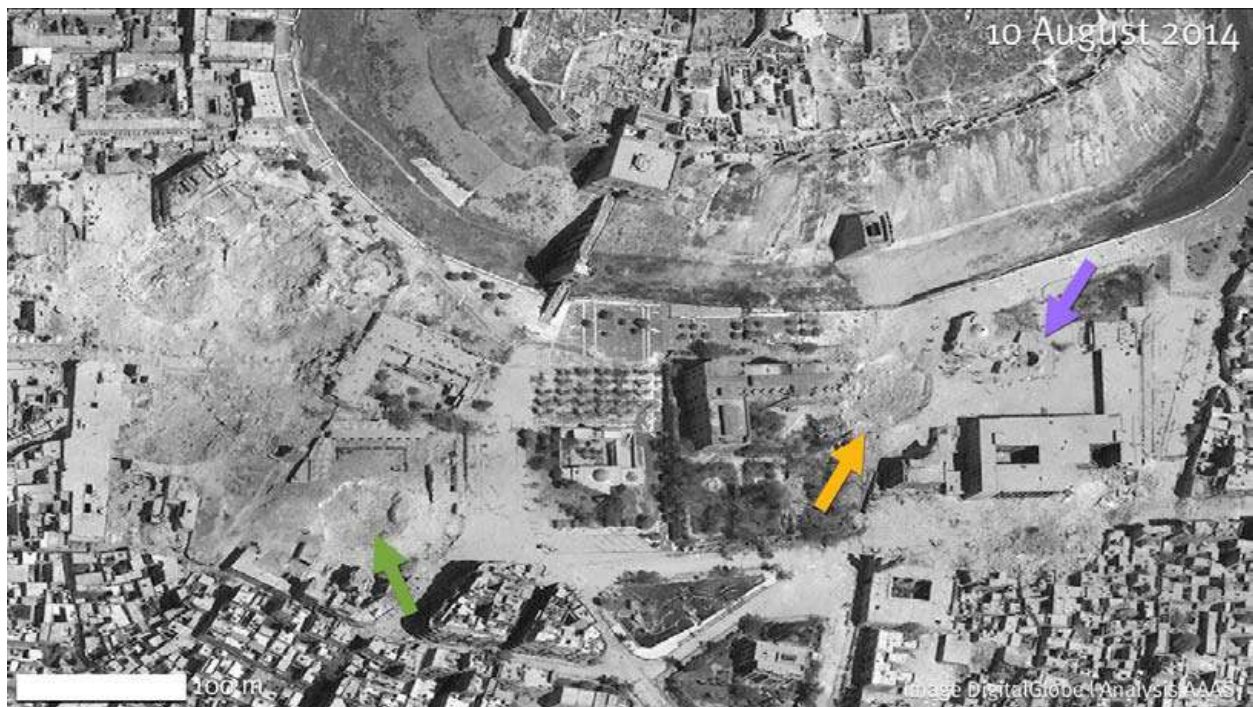
*Figure 4: Damage to the area south of the citadel*

Much of the heaviest damage was concentrated in the area immediately south of the citadel. This area contains government buildings, such as the Ministry of Justice headquarters, a police headquarters, and the Grand Serail of Aleppo, which was the main government building in the city under the French Mandate. Other historic structures that were damaged and destroyed include the Hammam Yalbougha an-Nasry (late 15<sup>th</sup> century), the Khusruwiye Mosque (mid-16<sup>th</sup> century), and the Carlton Citadel Hotel (19<sup>th</sup> century). By 14 July 2014, the Carlton Citadel Hotel and several adjacent structures had been completely destroyed, while the Khusriwiye Mosque, the Ministry of Justice building, and the police headquarters had been heavily damaged. Between 14 July 2014 and 10 August 2014, the Khusriwiye Mosque was almost completely destroyed, leaving a crater 40m in diameter where the building formerly stood. Similarly, a second 40m crater eliminated the east wing of the Grand Serail. The dome of the public bathhouse was also destroyed.

Between 6 December 2011 (top) and 14 July 2014 (middle), the Ministry of Justice building was heavily damaged (red arrow), as was the Khusriwiye Mosque (green arrow). The Carlton Citadel Hotel (blue arrow) was completely destroyed along with many surrounding structures (yellow arrows). By 10 August 2014, the Khusriwiye Mosque had been almost completely demolished (green arrow), the Grand Serail was heavily damaged (orange arrow) and the dome of the Hammam Yalbougha an-Nasry was destroyed (purple arrow). Images ©2014, DigitalGlobe, NextView License | Analysis AAAS. Coordinates 36.19N, 37.16E.

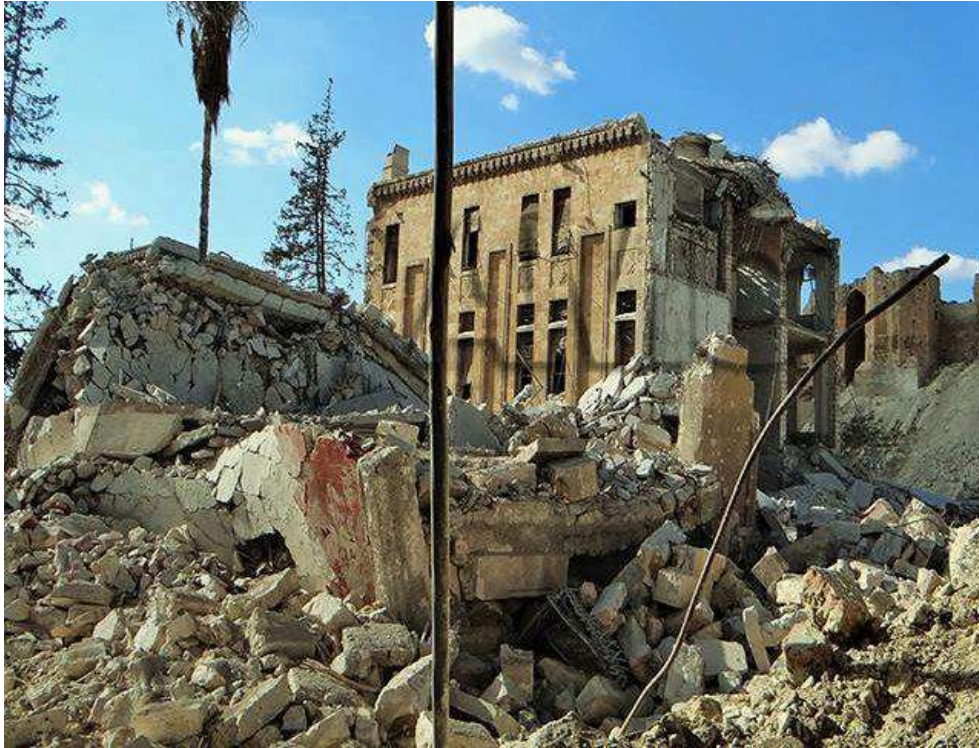
*Figure 5: Ground view of the Grand Serail in Aleppo*

*Ground view of the Grand Serail in Aleppo (The orange arrow in figure 4). Photo: Aleppo Archaeology September 2014. ([www.facebook.com/pages/Aleppo-Archaeology](http://www.facebook.com/pages/Aleppo-Archaeology))*

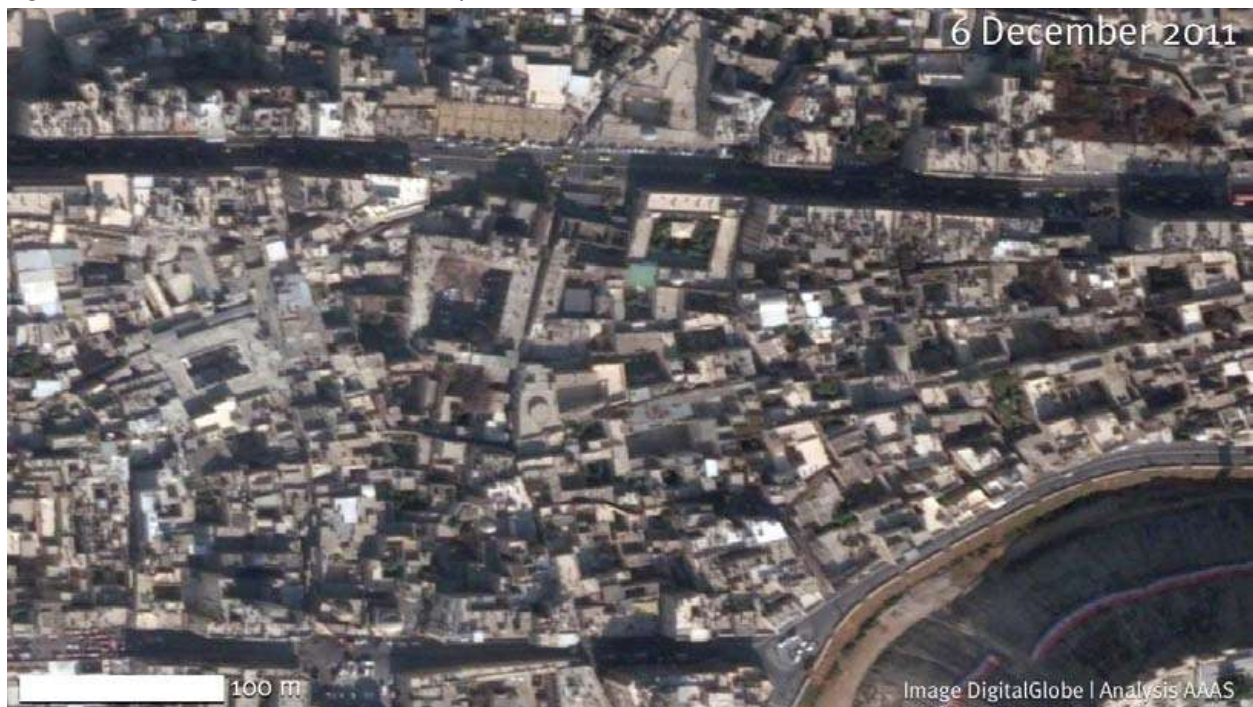
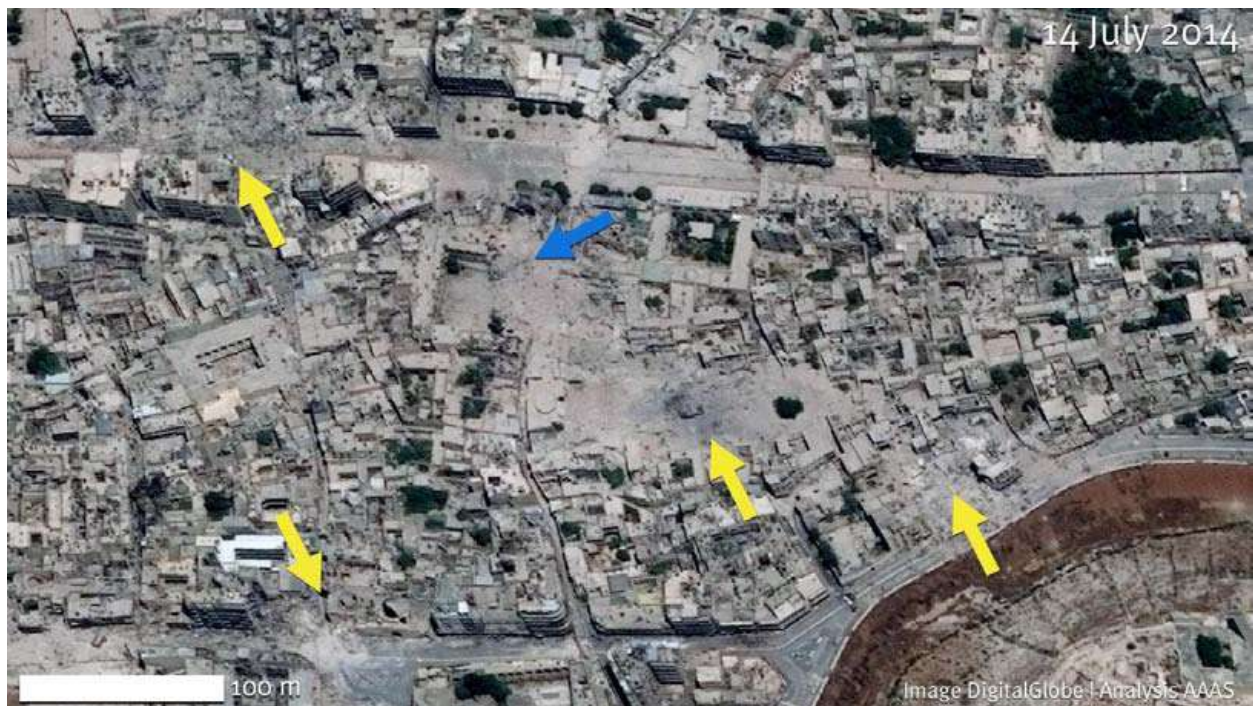
Figure 6: Damage to the Kahn Qurt Bey caravanserai

Satellite imagery also revealed substantial damage in the area north of the citadel. This area contains buildings dating from the late Mamluk period (13<sup>th</sup>-16<sup>th</sup> century) to the late Ottoman period (19<sup>th</sup> century). The east wall Khan Qurt Bey caravanserai, a historic site dating to the end of the 15<sup>th</sup> century, was also heavily damaged. In addition, most of the structures in the neighborhood immediately east of the caravanserai have been completely destroyed and nearby structures heavily damaged.

Between 6 December 2011 (top) and 14 July 2014, the east wall of the Kahn Qurt Bey caravanserai was demolished (blue arrow). Multiple other nearby structures were also heavily damaged (yellow arrows). Images ©2014, DigitalGlobe, NextView License | Analysis AAAS. Coordinates: 36.20N, 37.15E.

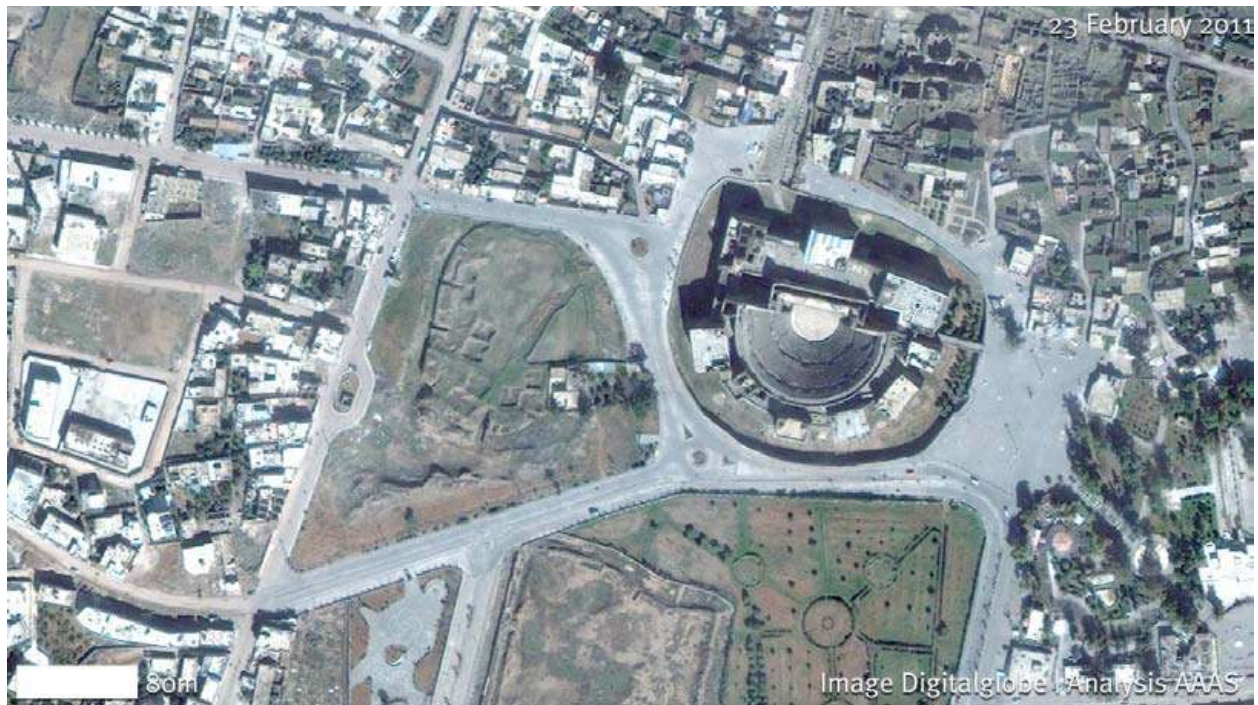
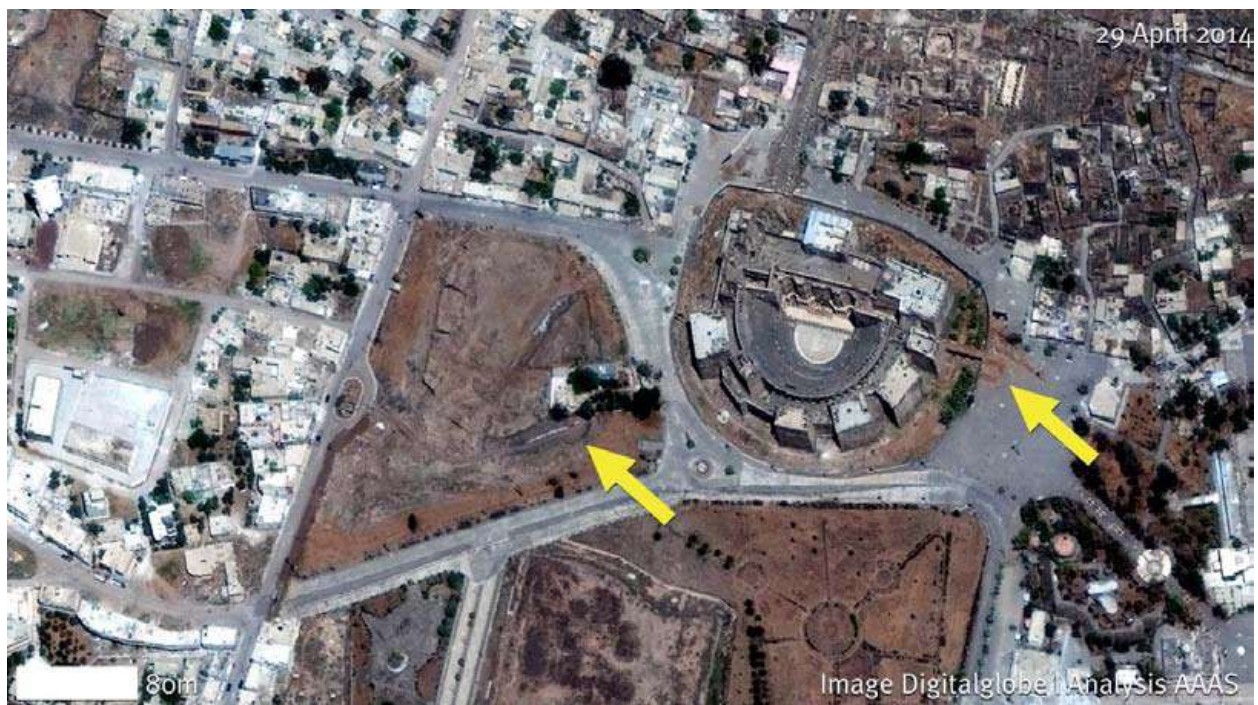
Figure 7: Earthen ramps and berms at the Bosra Roman Theater and nearby road excavations

Signs of conflict were evident in imagery of Bosra, and included phenomena such as roadblocks, destroyed buildings, and earthen fortifications in the modern city. Within the boundaries of the World Heritage site, the Roman theater, often considered the primary attraction of the Ancient City, showed no visible signs of damage, although an earthen ramp has been constructed over a staircase on its eastern entrance and that entryway is surrounded by berms (Figure 7). One hundred fifty meters to the west of the Roman theater, at an area of the site identified as the site of a second amphitheater, a vehicle track was observed leading to a low hillock, adjacent to a government building (Figure 7). In the northern portion of the heritage site, near its boundary with the modern city, two small high-albedo areas are visible, in a pattern that is consistent with mortar impacts. A hole observed in the nearby Al-Omari Mosque (AD 720) provides further evidence that this area was bombarded by mortars. Substantial damage was observed to a few modern buildings, and the shelling appears to have affected a relatively small portion of the Ancient City (Figure 8).

On 23 February 2011 (top), the Roman theatre and nearby archaeological site are undisturbed. By 29 April 2014, however, earthen ramps and berms have been constructed near the theater's east entrance, and a small hill at the site to the west has been partially excavated (arrows). Images ©2014, DigitalGlobe, NextView License | Analysis AAAS. Coordinates: 32.51N, 36.48E.

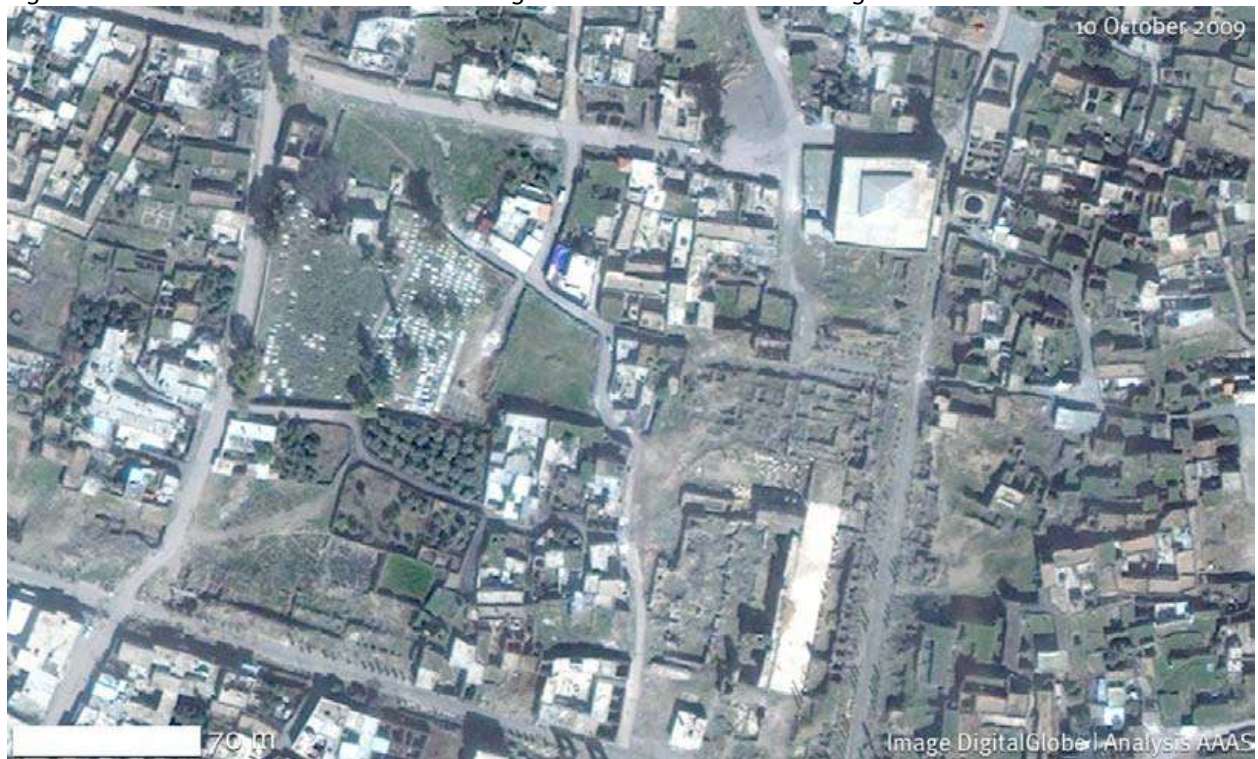
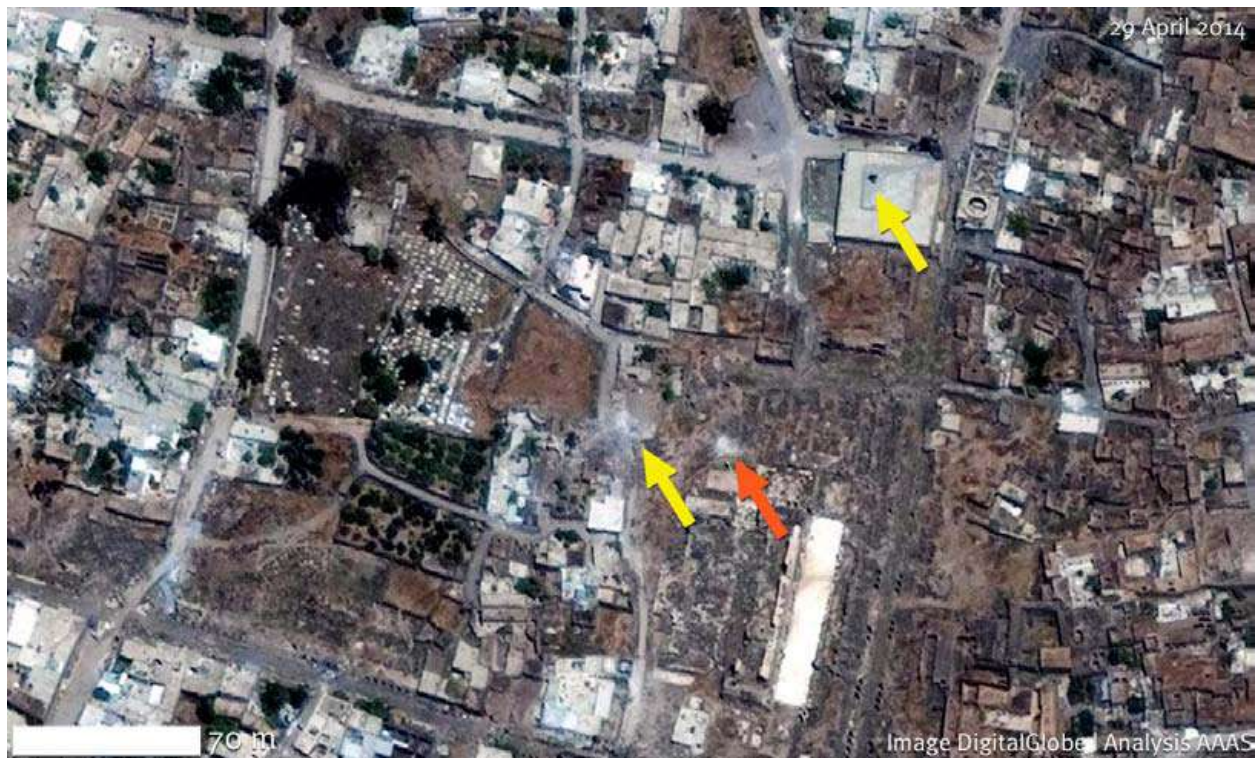
Figure 8: Shell craters and structural damage at the Bosra World Heritage site

Between October 2009 and April 2014, a number of probable shell craters associated with structural damage have appeared in the Bosra World Heritage site (yellow arrows) including a hole in the roof of the Al-Omari Mosque. A probable shell crater is also present in the standing ancient Roman ruins. Images ©2014, DigitalGlobe, NextView License | Analysis AAAS. Coordinates: 32.51N, 36.48E.

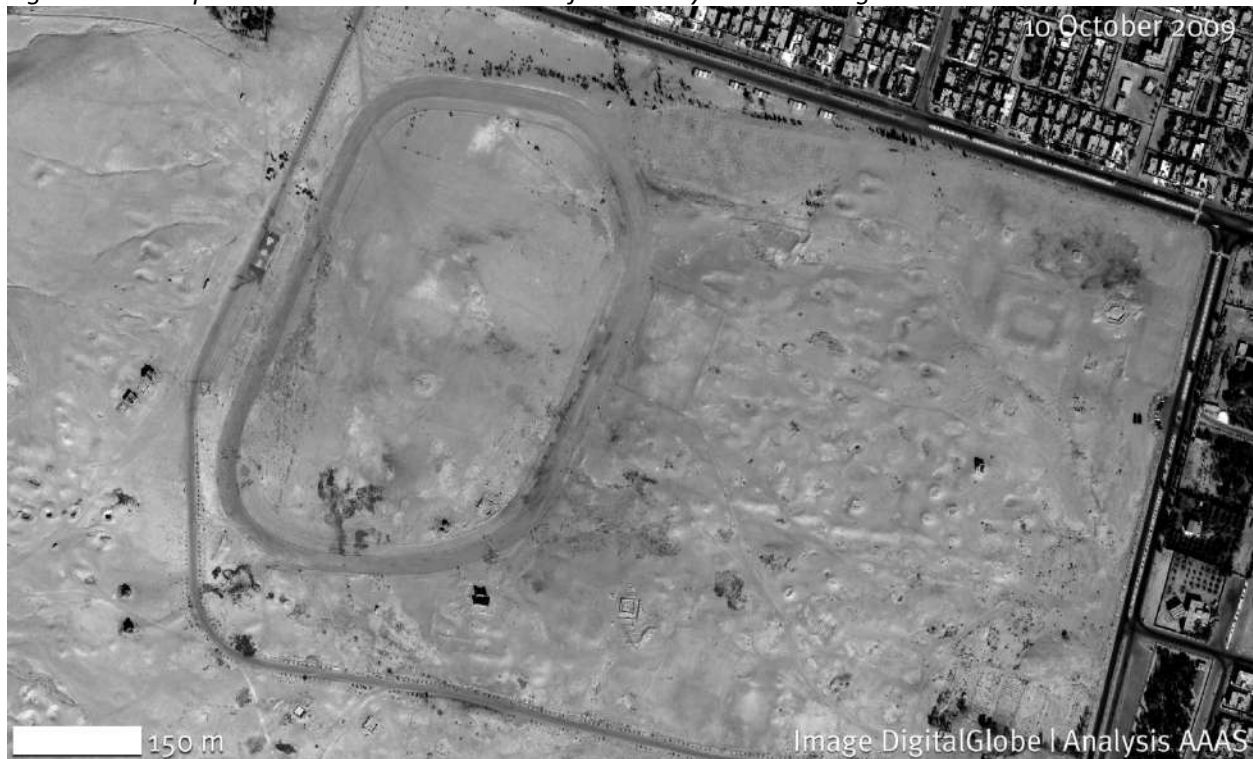
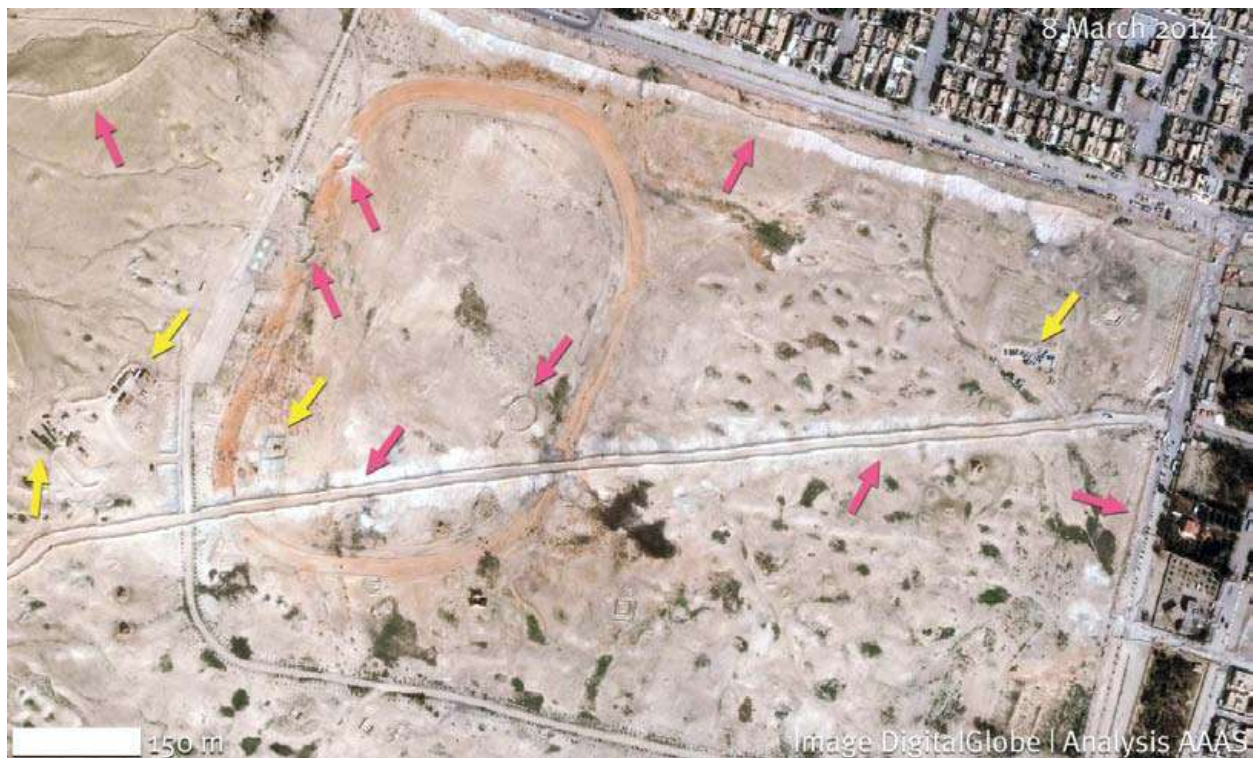
Figure 10: Disruptions in the Northern Section of the Palmyra Archaeological Park

A comparison of imagery revealed that the site of Palmyra had been substantially altered from its pre-conflict state. New roads, flanked by earthen berms, were cut through the center of the Northern area of the Palmyra Archaeological Park, and groups of military vehicles were visible occupying fortified positions at that location, as well as at a parking area built atop the ancient city wall, which was destroyed by this construction (Figures 10-12). Comparing this imagery to video acquired by ground-based activists reveals that some of these vehicles are BM-21 Grad multiple launch rocket systems. Also confirmed by ground-based imagery was the construction of temporary structures adjacent to Fakhr-al-Din al-Ma'ani Castle, in the northwestern corner of the site (Figure 11). Additional earthen fortifications, though unoccupied at the time of image acquisition, were scattered throughout the site (Figures 10 and 12). The effect of this massive earth movement on the site's archaeological integrity is unknown, but appears to be substantial. Within the Roman barracks of Diocletian's camp the previously well-defined outlines of ancient ruins appear to have been softened, though the precise reason for this is unclear (Figure 12). Ground-based photos show that several walls at the site, formerly intact, have been demolished and their building materials strewn about, providing one possible explanation for the phenomenon (Figure 13).

Between 10 October 2009 (top) and 8 March 2014 (bottom), the northern section of the Palmyra Archaeological Park has been disrupted by the construction of a new road traversing the site, and numerous earthen berms (pink arrows), many of which are being used to provide cover for military vehicles (yellow arrows). Images ©2014, DigitalGlobe, NextView License | Analysis AAAS. Coordinates: 34.55N, 38.26E.

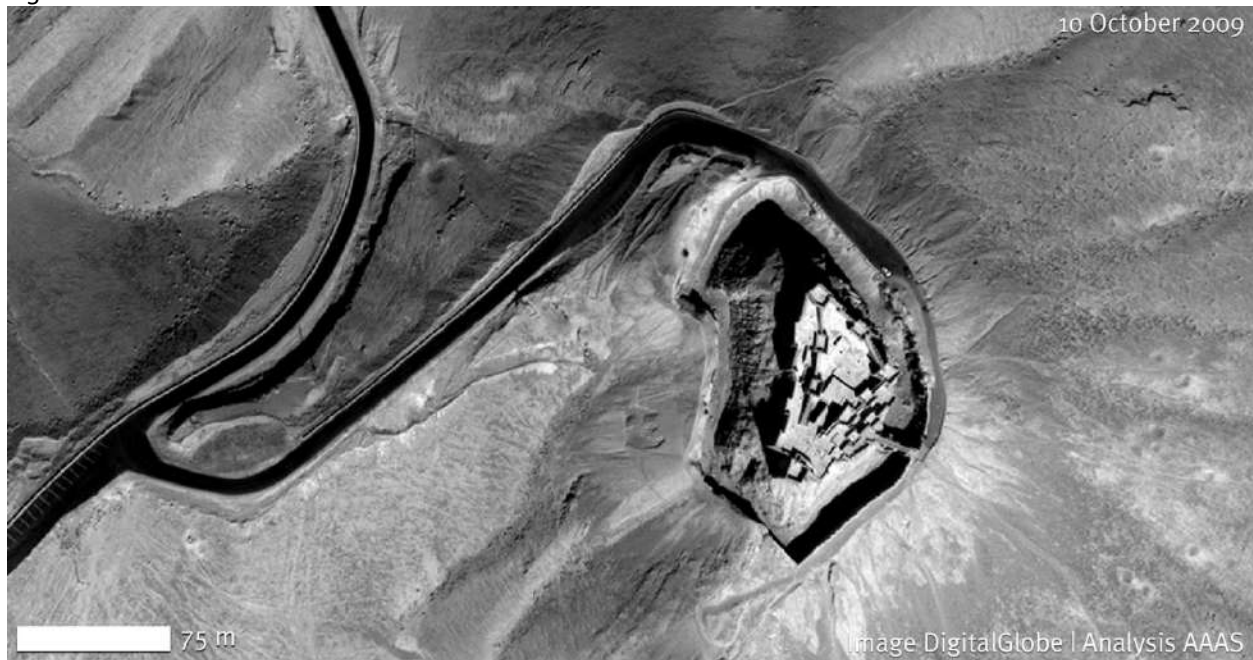
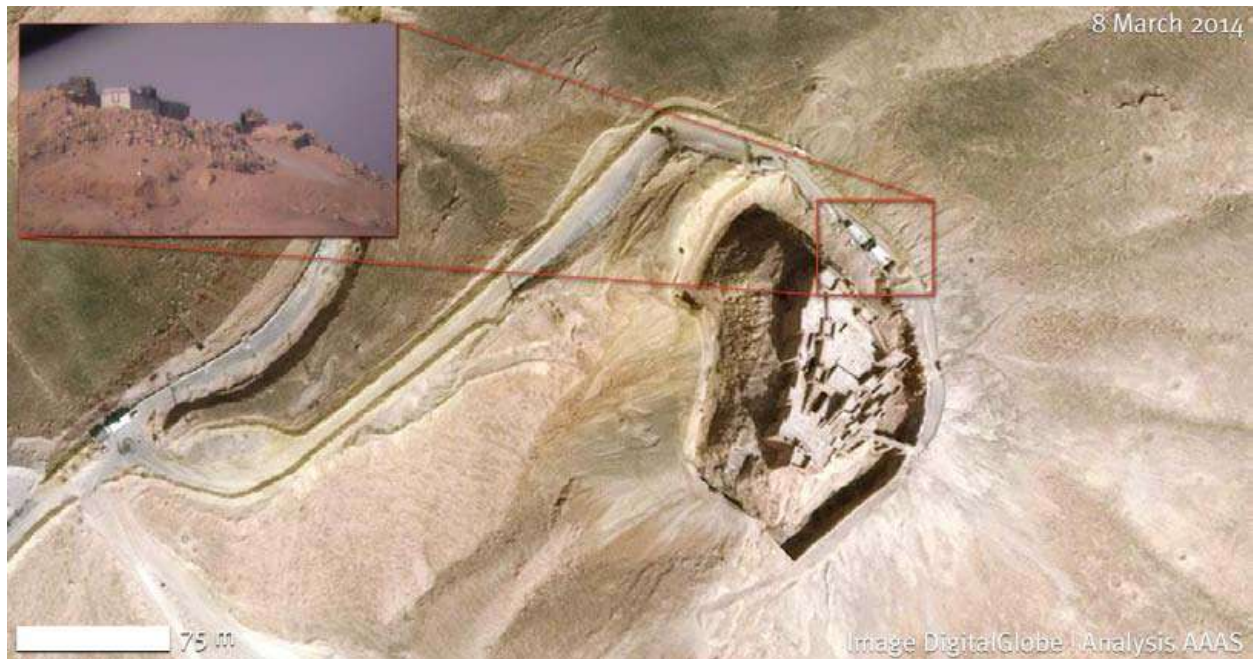
Figure 11: Trailers on the Fakhr-al-Din al-Ma'ani Castle

Between October 2009 (top) and March 2014 (bottom), the road leading to Fakhr-al-Din al-Ma'ani Castle has been reinforced with earthen berms, and two trailers have been emplaced near the citadel – an observation which corresponds to ground-based photographs (bottom, inset). Photo: Association for the Protection of Syrian Archaeology, August 2014 ([www.apsa2011.com](http://www.apsa2011.com)). Satellite images ©2014, DigitalGlobe, NextView License | Analysis AAAS. Coordinates: 34.55N, 38.26E.

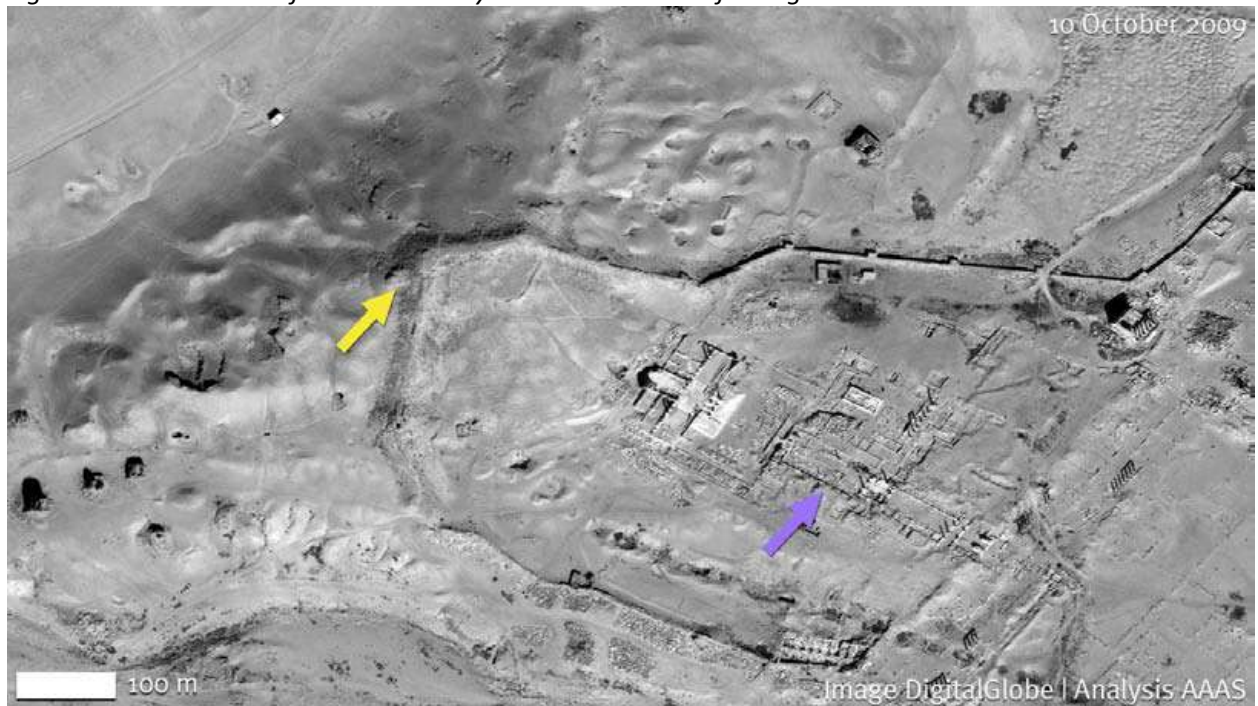
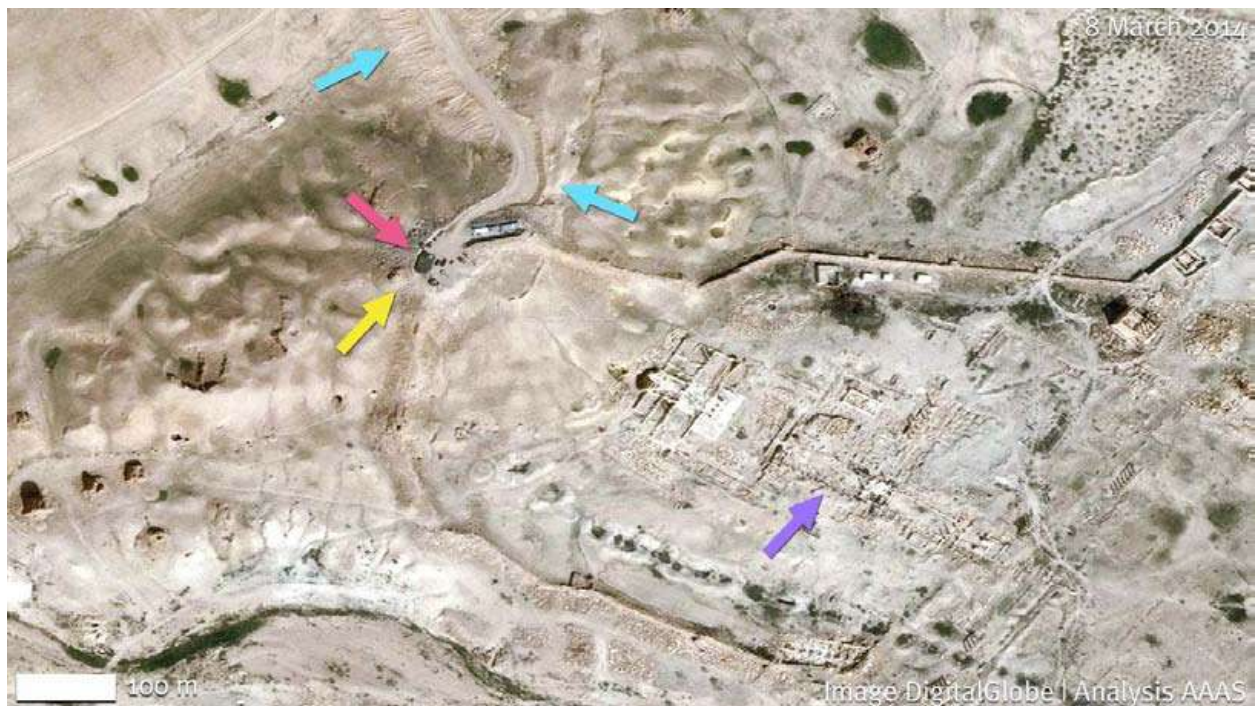
Figure 12: Destruction of the ancient city wall and terrain softening

The ancient city wall of Palmyra (yellow arrow) and the barracks of Diocletian's camp (purple arrow) are intact in October 2009 (top). By March 2014 (bottom), a portion of the wall has been destroyed for a military encampment (pink arrow), fortified by earthen berms (blue arrows), and the terrain in the camp has softened. Images ©2014, DigitalGlobe, NextView License | Analysis AAAS. Coordinates: 34.55N, 38.26E.

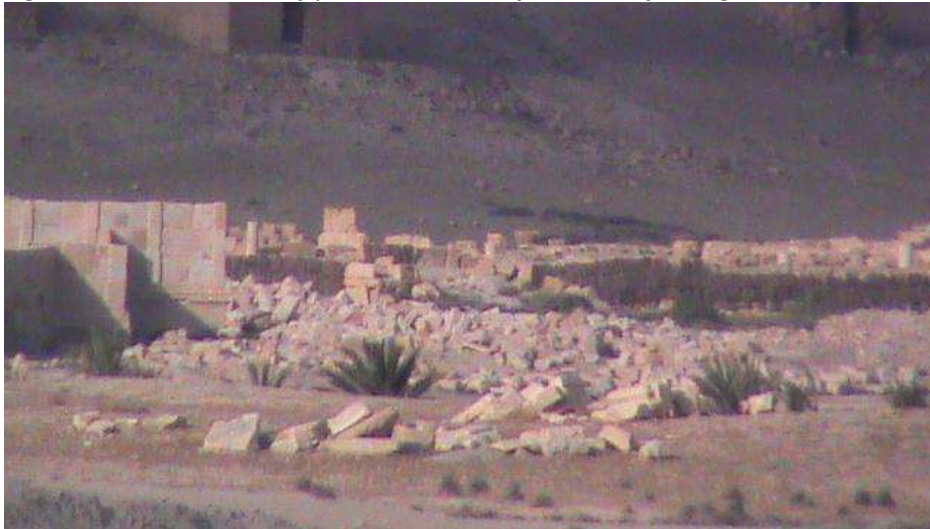
*Figure 13: Ground view of possible causes of terrain softening*

*Photo: Association for the Protection of Syrian Archaeology, August 2014 (www.apsa2011.com)*

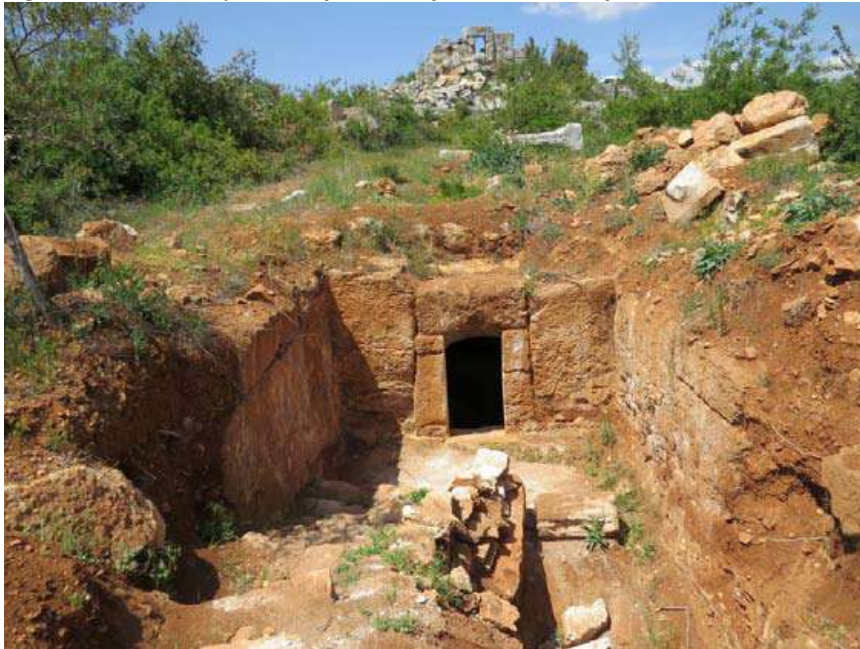
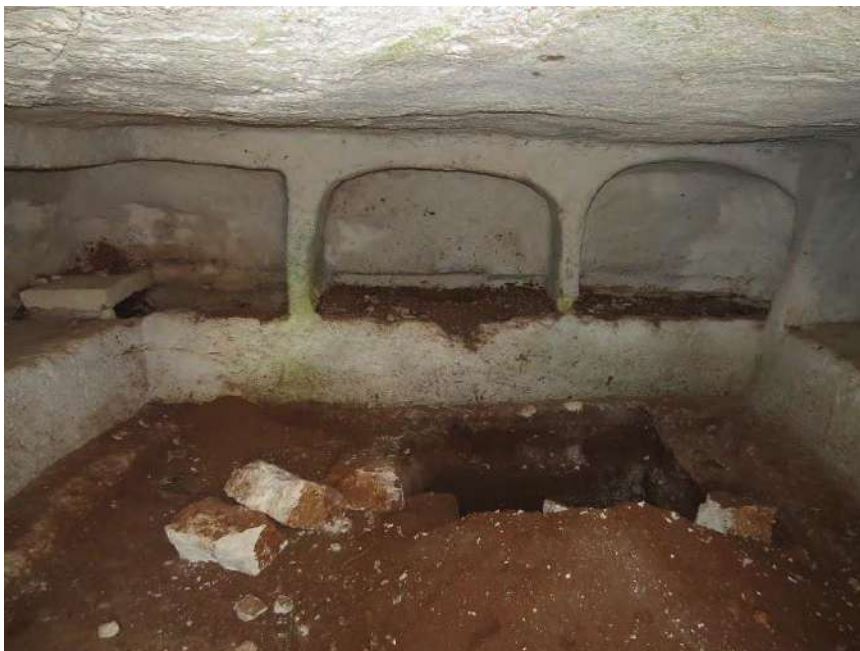
*Figure 15: Ground photos of a tomb from the site of Al Bara in the Jebel Zawiya Archaeological Park*

important to note that not all damage is visible in high-resolution satellite imagery, and the many reports of looting at these archaeological parks cannot be verified through this analysis. Affiliated ground assessments of this type of damage are ongoing (Figure 15).

*Ground photos of a tomb from the site of Al Bara in the Jebel Zawiya archaeological park illustrate looting that is not visible in satellite imagery. Source kept anonymous for protection. Distributed by Le patrimoine archéologique syrien en danger (PASD), 2013.*

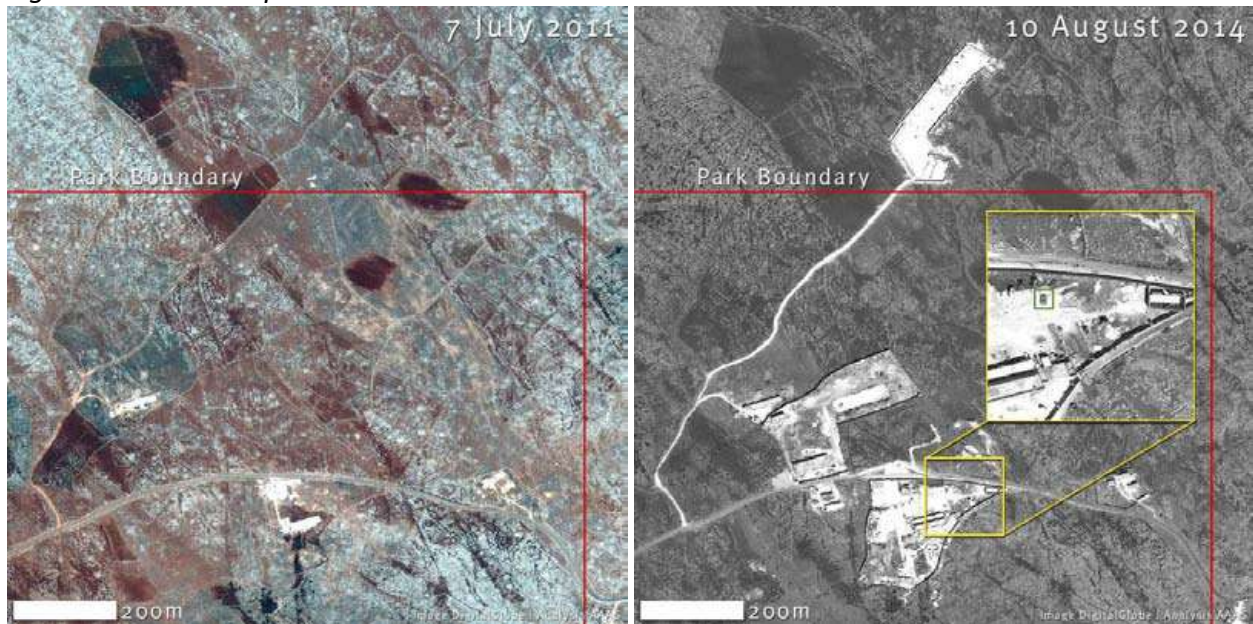
*Figure 16: New compounds at Jebel Barisha*

Three new compounds were constructed between 7 July 2011 (left) and 10 August 2014 (right). An armored vehicle (green square) was observed at one compound inside the park boundary Image ©2014, DigitalGlobe, NextView License | Analysis AAAS. Coordinates: 36.21N, 36.67E.

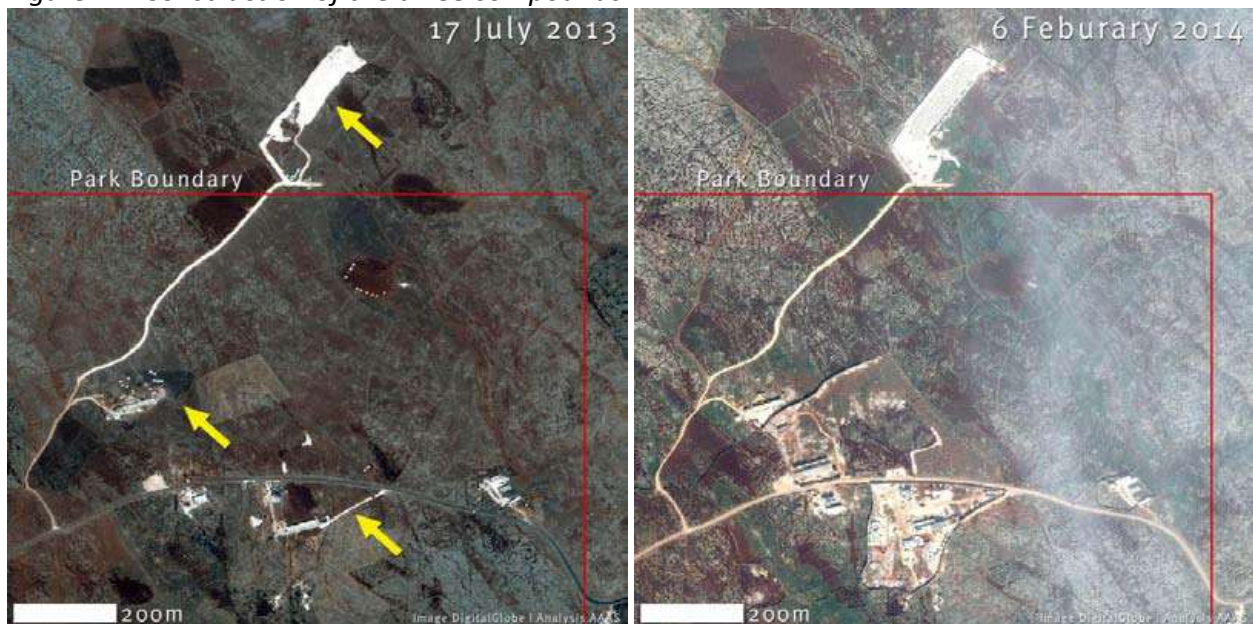
*Figure 17: Construction of the three compounds*

Construction of the compounds was underway by 17 July 2013 and appears to have been completed by 6 February 2014. It involved the construction of two compounds in the southern area and one in a northern location (Figure 17). Heavy vehicles were observed at the southern two compounds, but the only distinctly military equipment observed was the armored vehicle present on 10 August 2014.

Construction on all three compounds had begun by 17 July 2013 (yellow arrows, left) and was completed by 6 February 2014 (right). Image ©2014, DigitalGlobe, NextView License | Analysis AAAS. Coordinates: 36.21N, 36.67E.
