# Ancient history, modern destruction:

Assessing the current status of Syria's World Heritage sites  
using high-resolution satellite imagery

September 2014

# Ancient History, Modern Destruction: Assessing the Current Status of Syria's World Heritage Sites Using High-Resolution Satellite Imagery

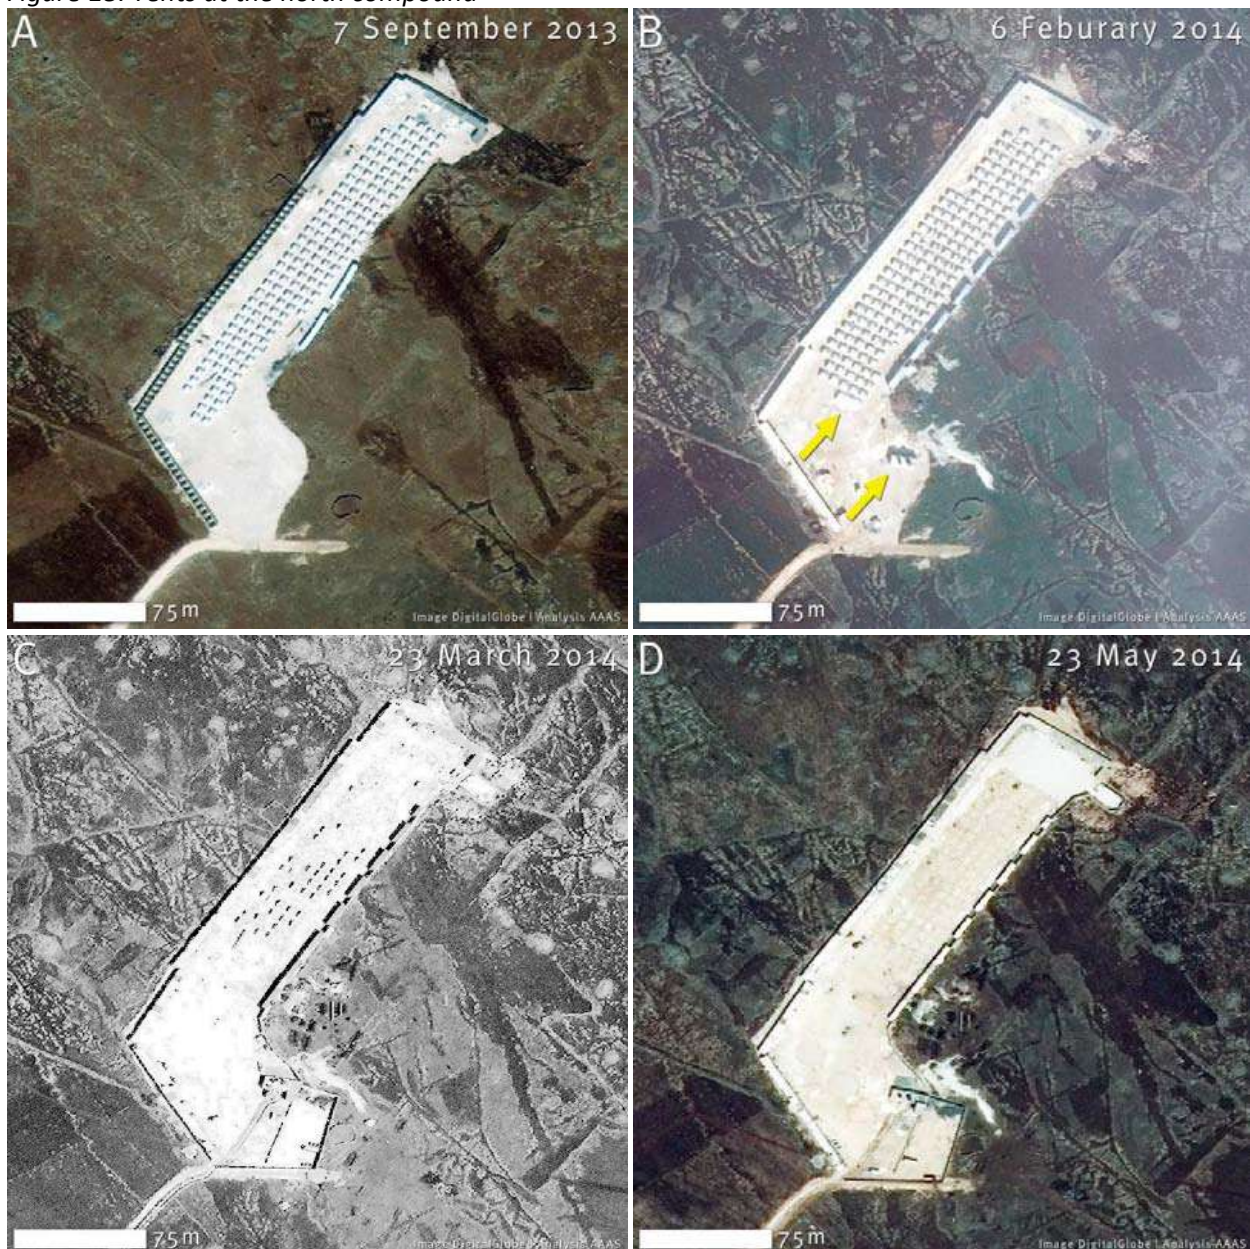
*Figure 18: Tents at the north compound*

At the northern compound, 148 structures, possibly tents, were observed on 7 September 2013. The structures had dimensions of approximately 4x4m and were laid out in orderly rows, which suggest a military purpose. By 6 February 2014, the tents had been rearranged slightly, and nine new tents were present, bringing the total to 157. In addition, two larger structures had been added. By 23 March 2014, only 39 tents remained at the site and all had been removed by 23 May 2014 (Figure 18).

On 7 September 2013 (A), 148 tents were observed at the north compound. By 6 February 2014 (B), the tents had been rearranged slightly and two larger structures had been added (yellow arrows). On 3 March 2013 (C) only 39 tents were present and all had been removed by 23 May 2014 (D). Image ©2014, DigitalGlobe, NextView License / Analysis AAAS. Coordinates: 36.22N, 36.67E.

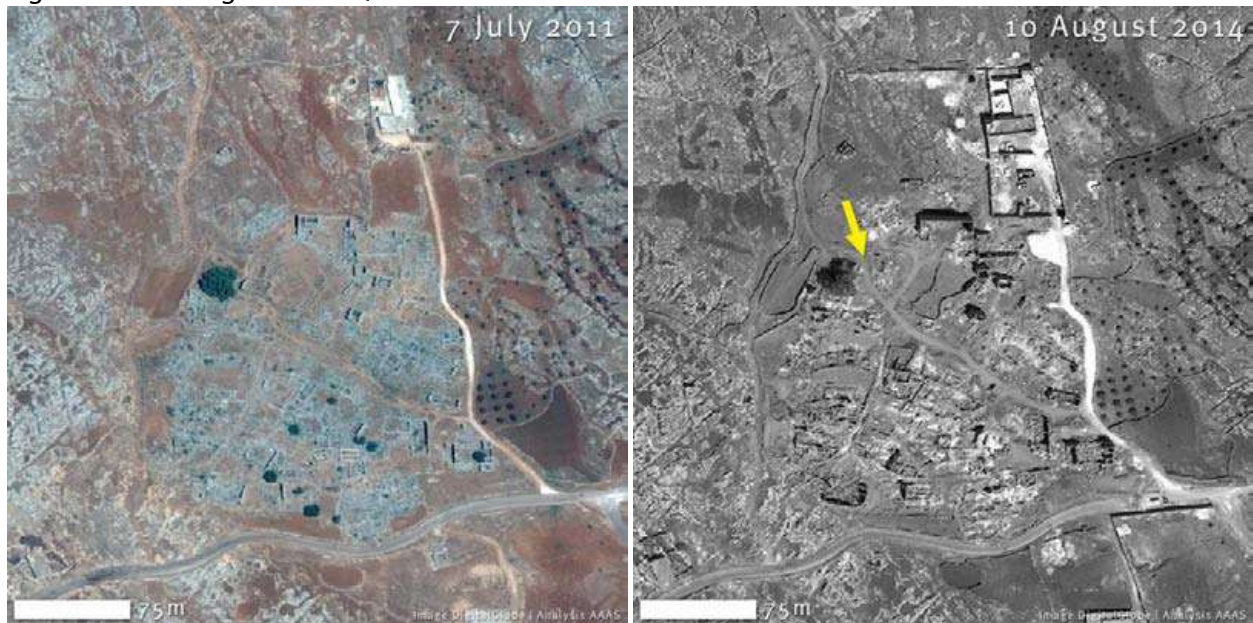
*Figure 19: Damage to Dar Qita*

In addition to the construction of military compounds in and around the park, damage to two archeological sites was observed. At the ancient village site of Dar Qita, standing ruins were knocked down to make way for a new road (Figure 19). New structures were also observed within the site of Bamuqa (Figure 20). Bamuqa straddles the park boundary, but new structures were observed on both sides of the boundary.

Between 7 July 2011 (left) and 10 August 2014 (right), a standing ruin was knocked down to make way for a new road (yellow arrow). Image ©2014, DigitalGlobe, NextView License | Analysis AAAS. Coordinates: 36.21N, 36.66E.

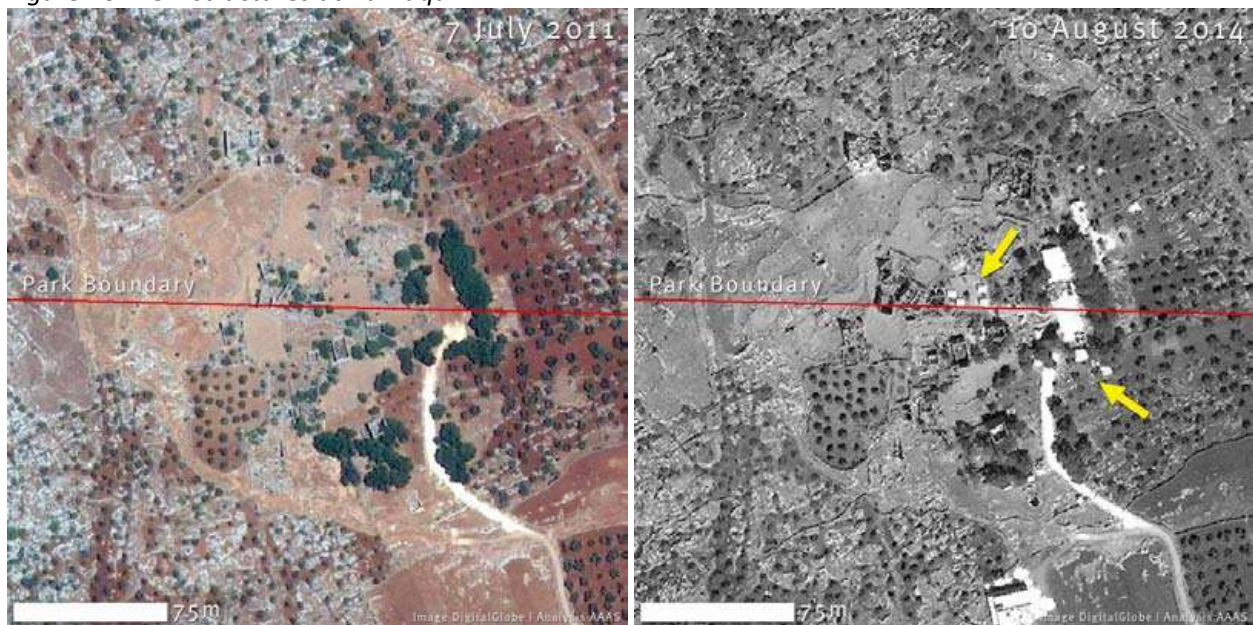
*Figure 20: New structures at Bamuqa*

Multiple tents (yellow arrows) appear at Bamuqa between 7 July 2011 and 10 August 2014. Image ©2014, DigitalGlobe, NextView License | Analysis AAAS. Coordinates: 36.20N, 36.63E.

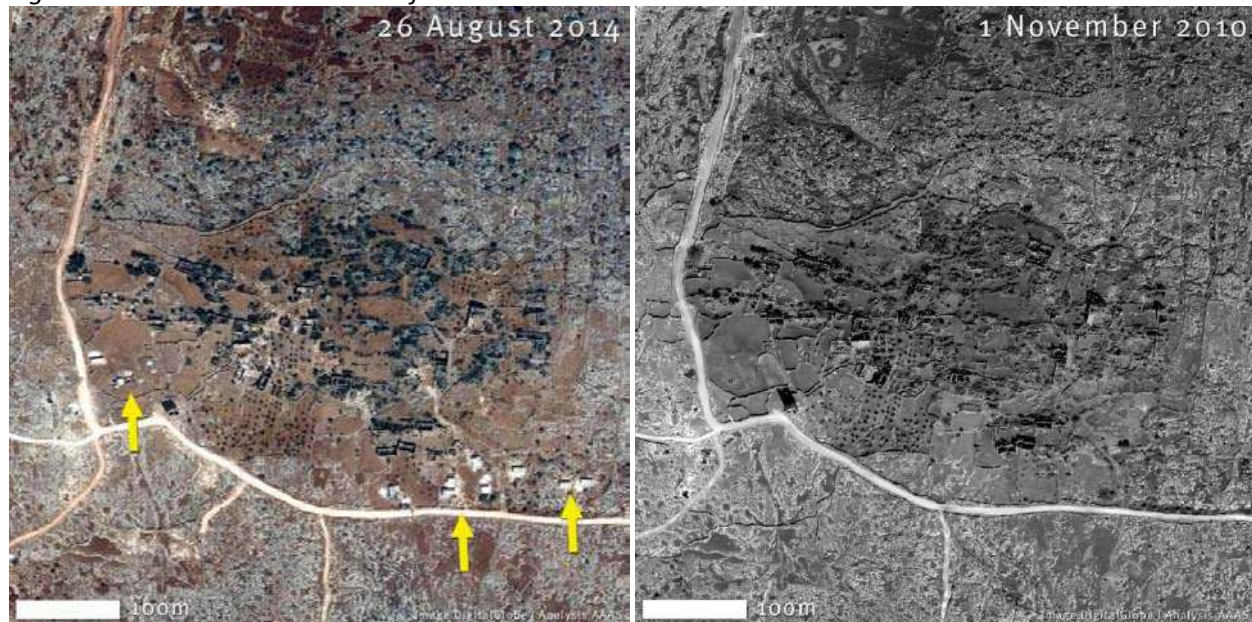
Figure 21: New structures near Refade

In addition to the damage to Takleh, new structures were observed on and near archeological sites. At the Dead City site of Refade, multiple tent-like structures were observed within the ruins (Figure 21). Several new structures were also observed near the town of Deir Semaan. The town is situated between archeological sites. Between 1 November 2010 and 26 August 2014, structures were built on, or in close proximity to, some of these sites (Figure 22). Finally, a tent-like structure was erected inside the walls of the Basilica of Saint Simeon (Figure 23).

Multiple new structures (yellow arrows) appear between 1 November 2010 (left) and 26 August 2014 (right). Image ©2014, DigitalGlobe, NextView License | Analysis AAAS. Coordinates: 36.31N, 36.82E.

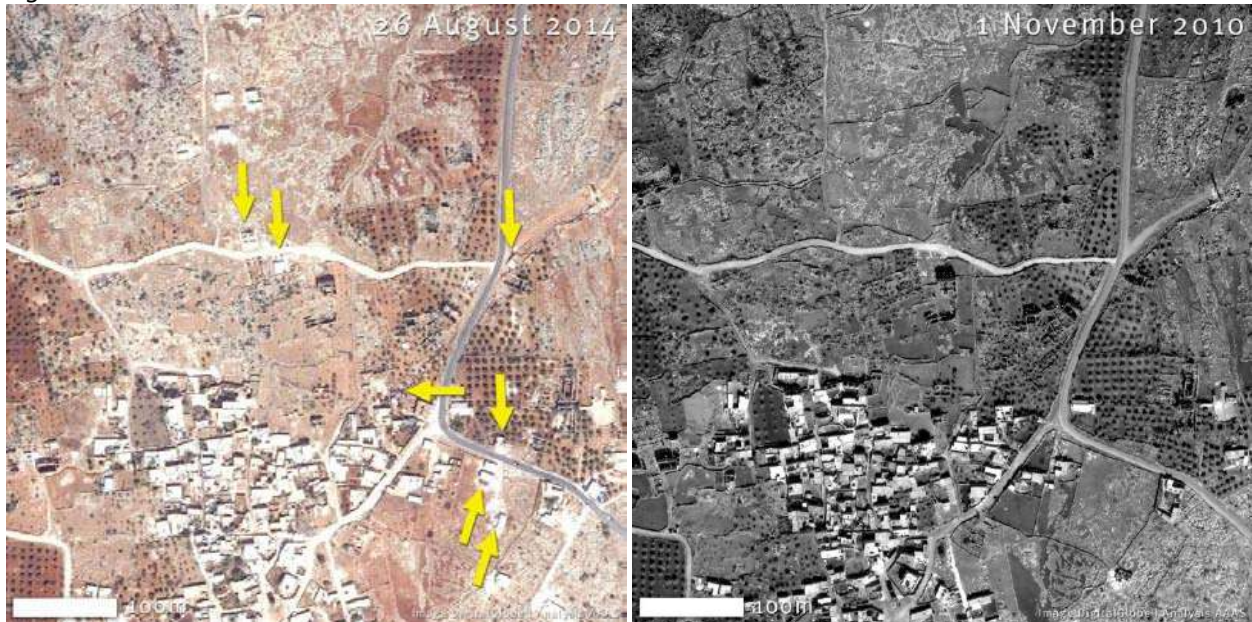
*Figure 22: New structures at Deir Semaan*

Multiple new structures appear between 1 November 2010 (left) and 26 August 2014 (yellow arrows, right). Image ©2014, DigitalGlobe, NextView License | Analysis AAAS. Coordinates: 36.21N, 36.83E.

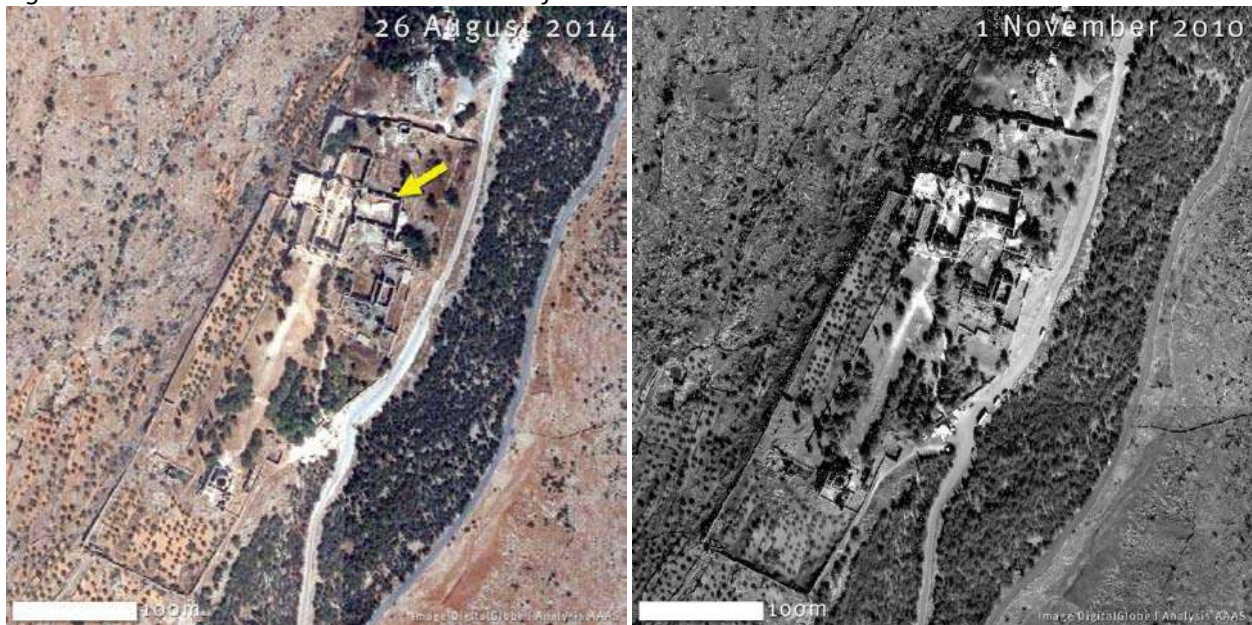
*Figure 23: New structure within the Basilica of Saint Simeon*

A tent-like structure (yellow arrow) was observed within the Basilica of Saint Simeon on 26 August 2014 (right). Image ©2014, DigitalGlobe, NextView License | Analysis AAAS. Coordinates: 36.33N, 36.84E.

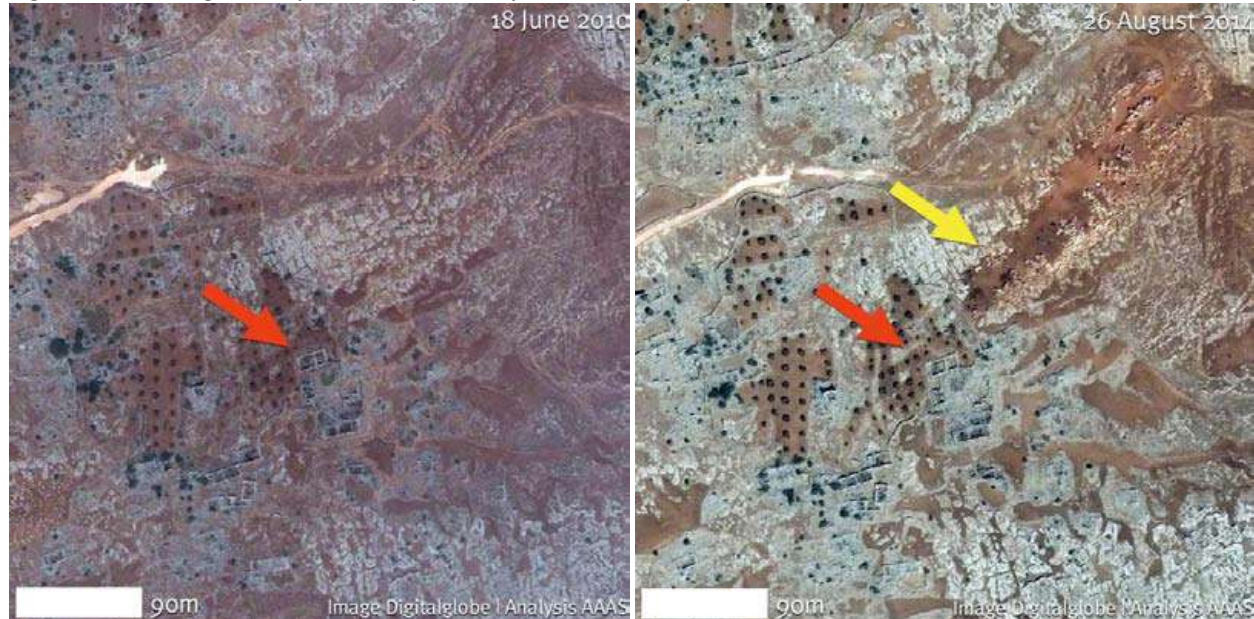
Figure 24: Mining activity in close proximity to ancient city

Between 2010 (left) and 2014 (right), mining activity (yellow arrow) has taken place directly adjacent to Kafr Nabo, an archaeological site inside the Jebel Seman 2 World Heritage Site (red arrows). Image ©2014, DigitalGlobe, NextView License | Analysis AAAS. Coordinates: 36.35N, 36.91E.

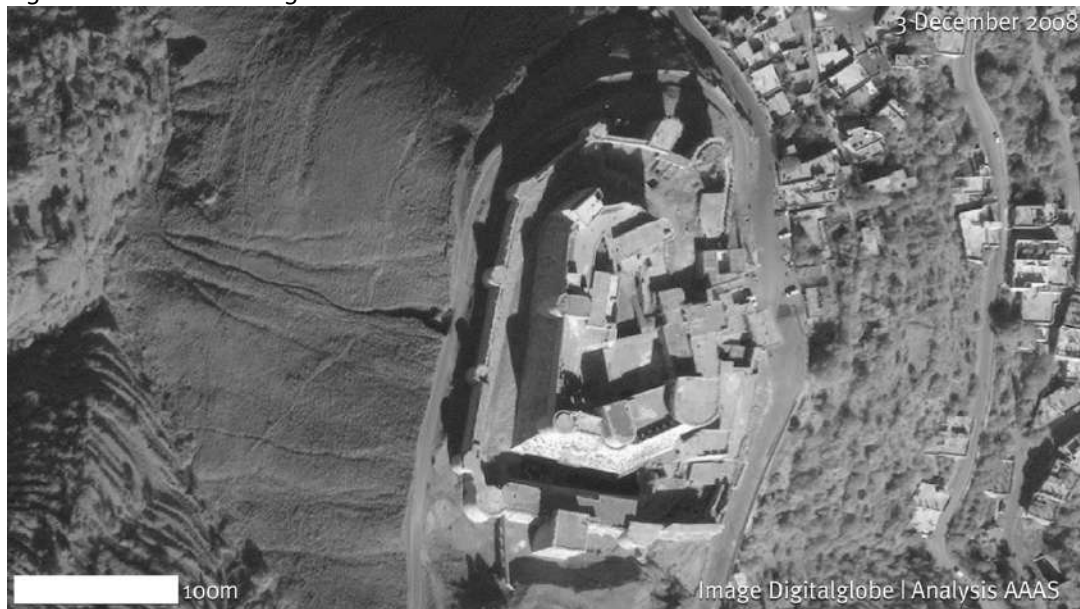
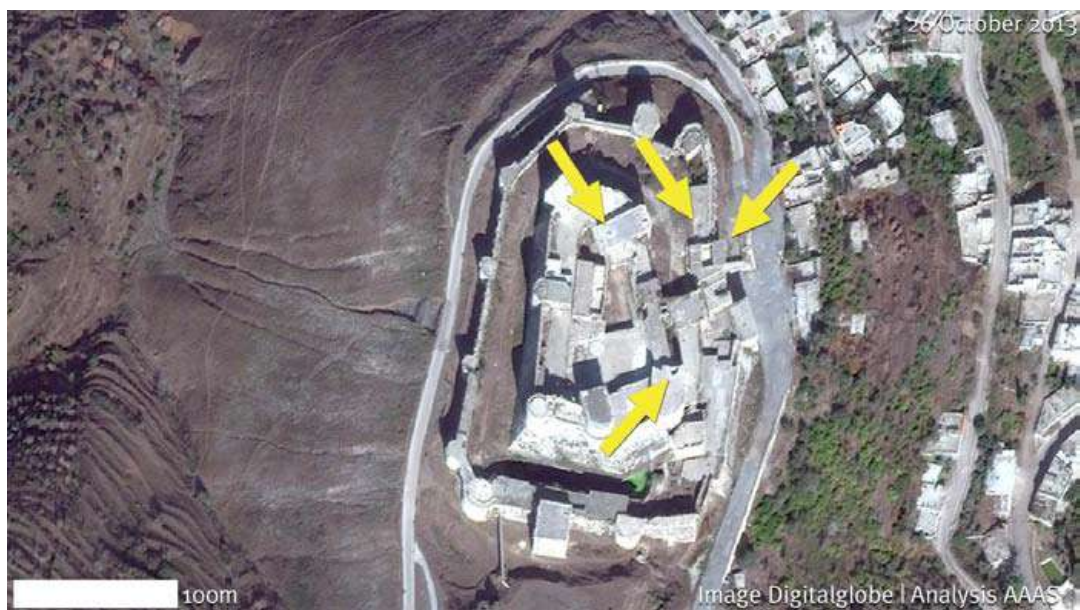
Figure 25: Visible damage to Crac des Chevaliers

Crac des Chevaliers appears to have sustained moderate structural damage. Its southeast tower has sustained damage measuring approximately 6m across, with an associated debris apron upon the lower parts of the structure. Three additional craters are visible on the northern areas of the castle, although, unlike the impact on the south tower, none of these appear to have penetrated the roof (Figure 25). At Qal'at Salah El-Din, no damage to the structure was apparent, although a single structure, which may have been temporary, was observed to have disappeared from the car park between 2010 and 2014.

Between 2008 and 2013, a number of craters (yellow arrows) have appeared at Crac des Chevaliers, one of which appears to have breached the roof of the south turret. Image ©2014, DigitalGlobe, NextView License | Analysis AAAS. Coordinates: 34.75N, 36.29E.
